# Multiple Flow Processes Accompanying a Dam-break Flood in a Small Upland Watershed, Centralia, Washington

U.S. GEOLOGICAL SURVEY

Water-Resources Investigations Report 94-4026

By John E. Costa

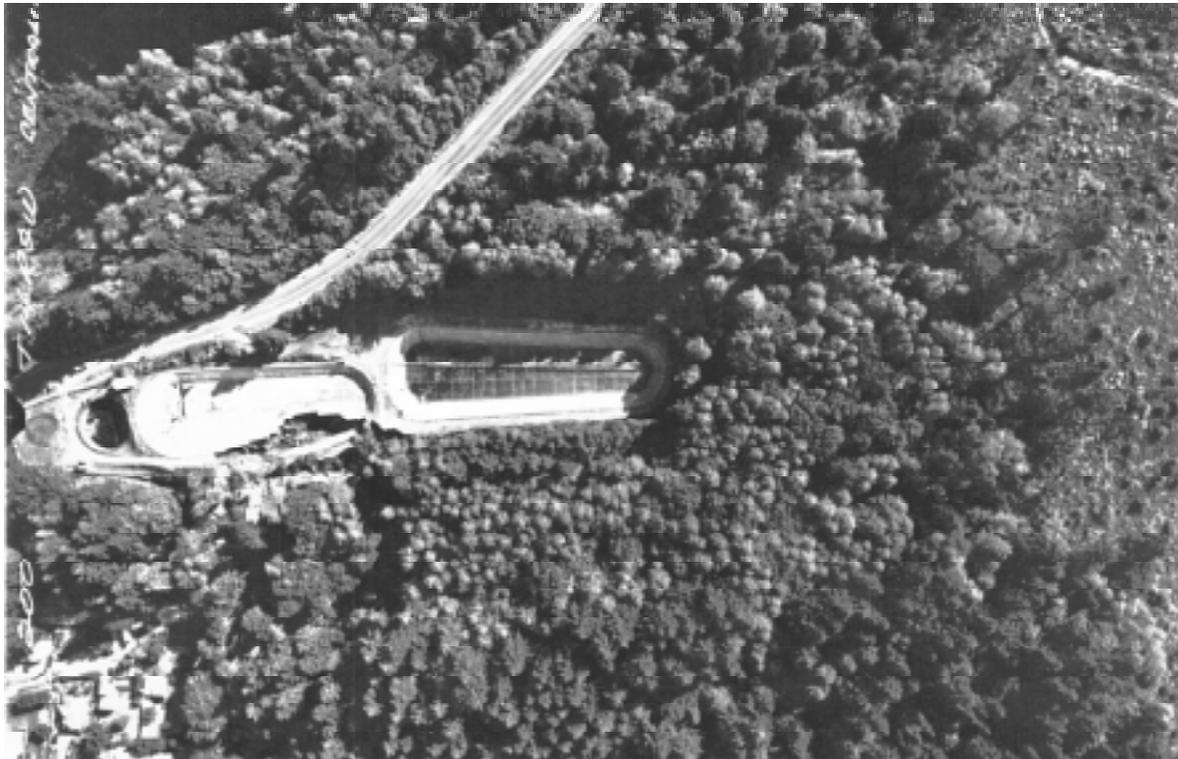
Figure 2. Aerial photograph of failed reservoir. East is at top of photo; ground slopes steeply to the west.

The mass movement that caused the immediate failure of the reservoir was a relatively deep slide in bedrock that left a near-vertical headwall, and curved

failure surface that extended to an estimated depth of 25 to 35 meters. Depth of the failure surface was estimated from the elevation difference between the reservoirs and toe of the slide bulging on the hillside below the reservoirs (fig. 3). The failed block of rock and fill moved downward about 9.1 m, and westward (outward) approximately 6.1 m, separating the concrete slabs that lined the floor of Reservoir Number 3 and opening a 40-meter gash in the southwest side of the reservoir. Post-failure slumping and sliding obscured the original morphology of the breach in the reservoir. Five days after the failure, the detached slump block had two breaches through which water discharged. The first breach was on the north end of the failure block. The depth of the breach was about 6 meters, and breach width was about 3-4 meters at the time of my visit, but the geometry had been obviously narrowed by post-failure bank collapse. A slightly smaller breach was located about 7 meters south of the first breach, but it too had been significantly modified by post-failure ground movements.

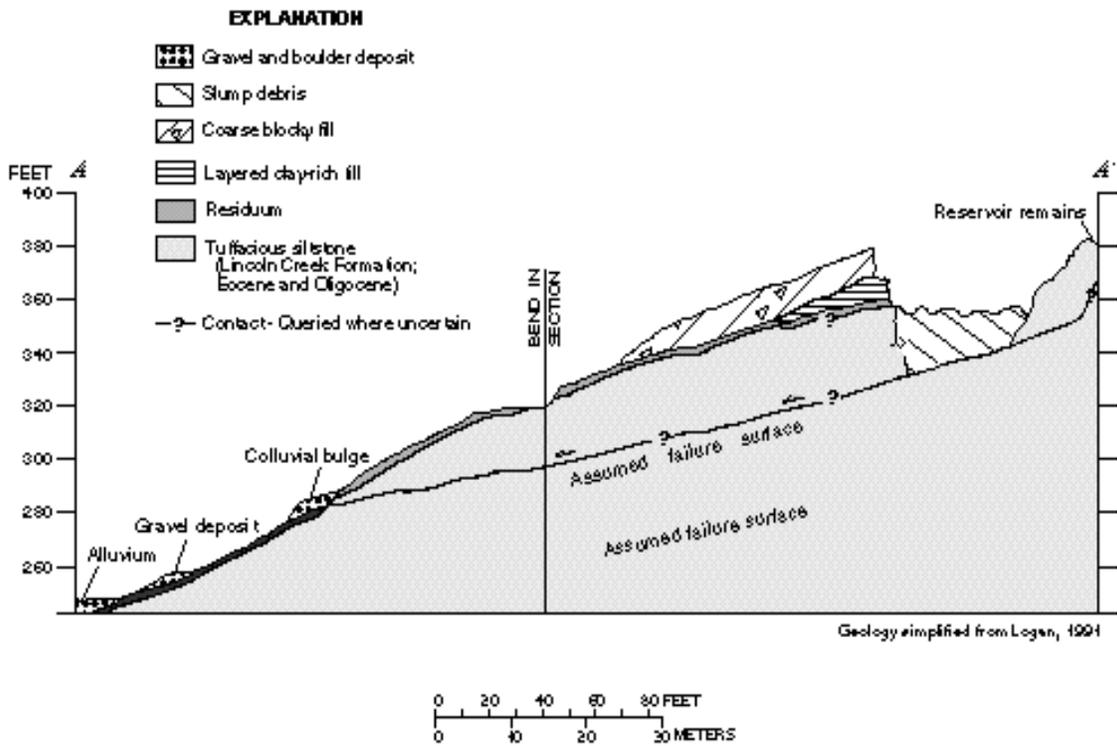
Figure 3. Geologic section of the area down-slope of Reservoir Number 3 (after Logan, 1991). Location of cross section A-A' marked on figure 5.

slope is covered by 3.0-3.5 m of coarse sandy gravel and boulder fill of highly weathered tuffaceous siltstone. This fill probably originated from the bedrock excavations for the reservoirs, and was severely eroded by floodwaters when Reservoir Number 3 drained (fig. 3).

The failure surface of the landslide that led to the reservoir collapse is in the tuffaceous siltstone of the Lincoln Creek Formation. Bedrock beneath the reservoir floor exposed by the landslide and flood is massive, spheroidally weathered and sparsely to densely jointed. Joints strike approximately east-west, and north-south, and have near-vertical dip. Along the failure surface, the siltstone was extensively broken and shattered into gravel and boulder-sized angular fragments. Well-developed slickensides were formed in the clay-rich fill and residuum and in the upper 40 cm of bedrock beneath the floor of the reservoir.

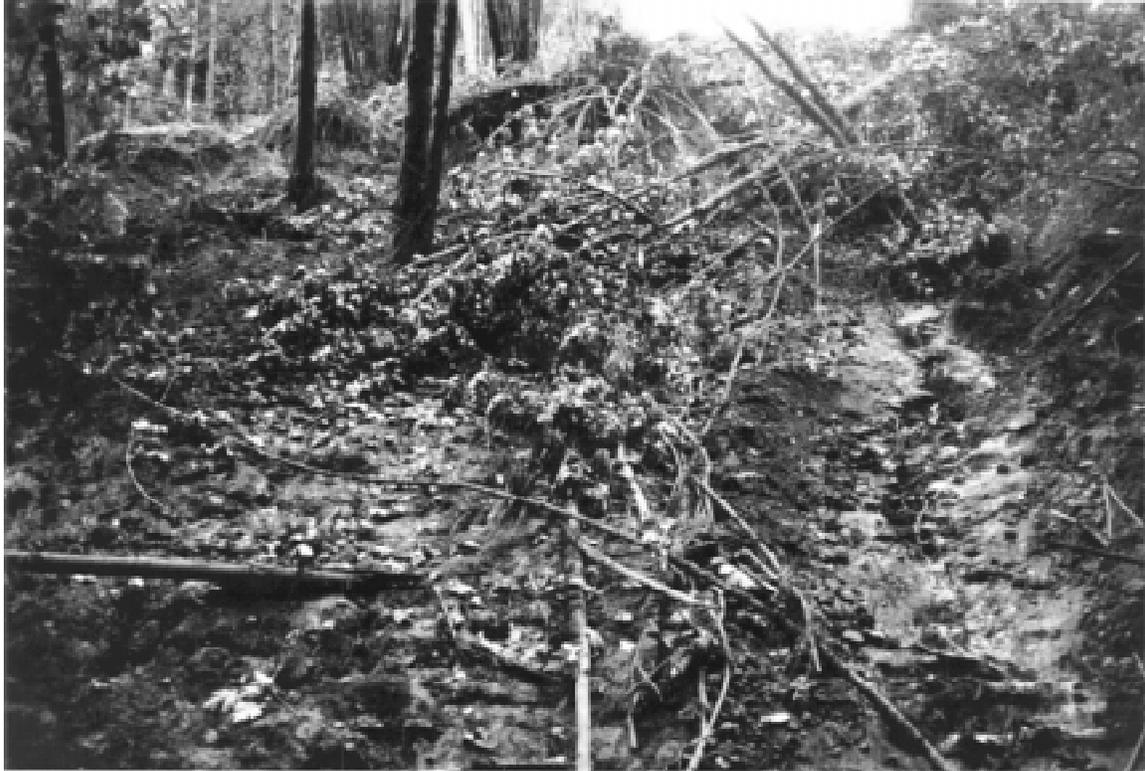
**Figure 4.** Hillslope below Reservoir Number 3 that has been washed and eroded by overland flow. View is upslope.

Below the breaches the ground was washed by sheetflow and there was substantial erosion of fill, colluvium, residuum, and some bedrock (fig. 4).

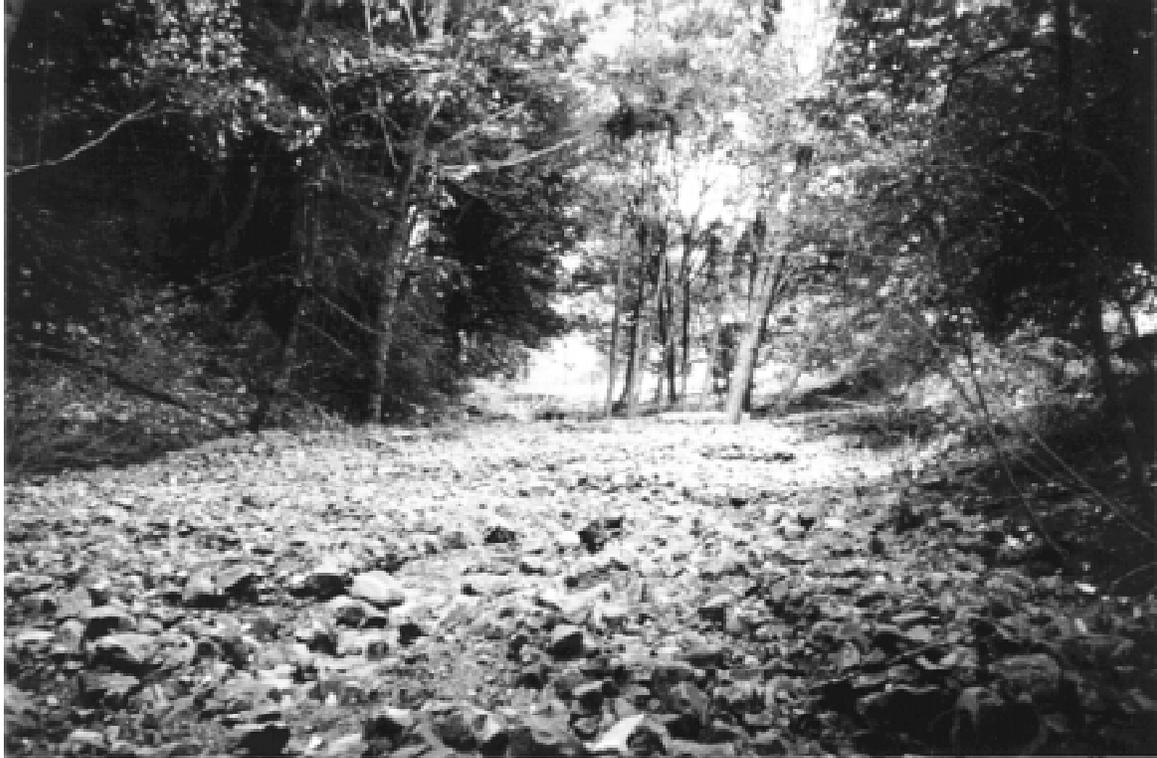
**Figure 6.** Massive gravel deposit upstream from the slope-area reach. View is downstream.

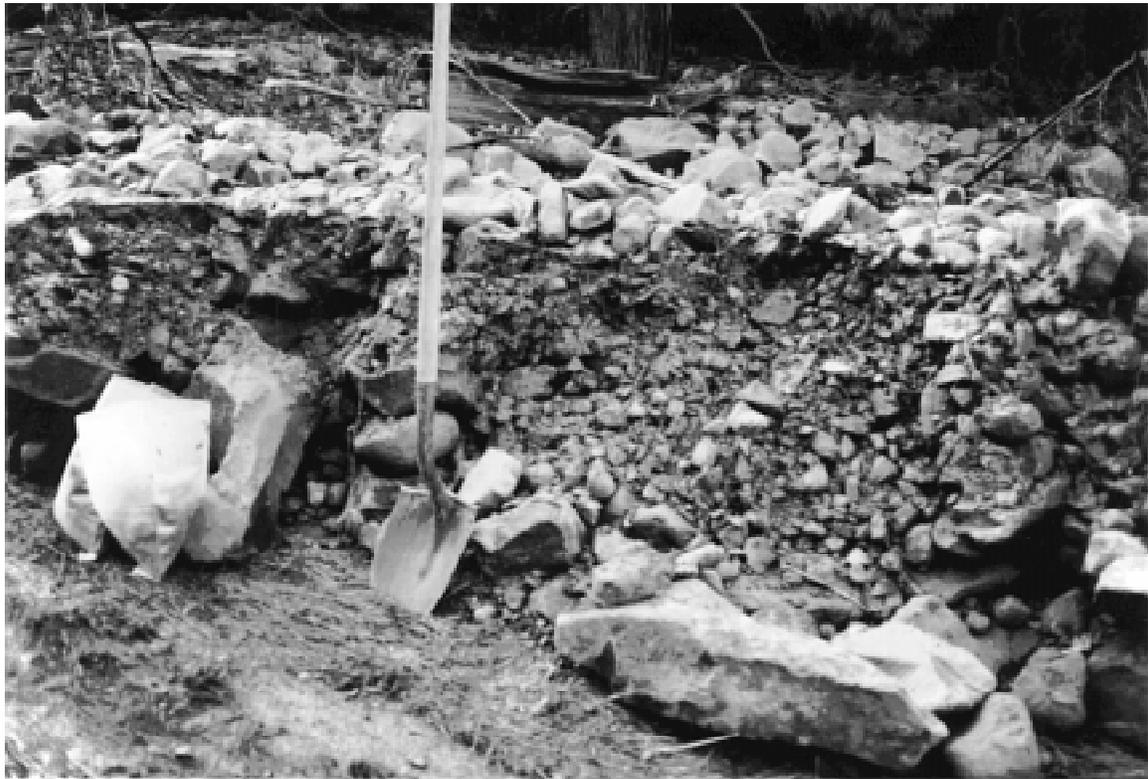
In cut banks of newly-deposited gravel in the slope-area reach, the washed surface of clean gravels and boulders was immediately underlain by a sandy gravel deposit in which many clasts were separated from others by a matrix of sand and silt (fig. 7). A mechanical analysis of one gravel sample is shown in figure 8. The median particle size is about 14 mm, and the shape of the frequency curve and sorting ( $\sigma = 2.1$ ) is characteristic of debris flow deposits (Scott, 1988). A mechanical analysis of coarse, gravel fill collected from the hillslope just below a breach in the down-dropped section of bedrock under the reservoir is also plotted in figure 8. This coarse fill is presumably the source material for most of the downstream gravel deposits. Median particle size is about 8 mm, and curve shape and sorting ( $\sigma = 2.2$ ) is very similar to the down-valley inferred debris-flow material. The derivative down-valley deposit is depleted in fines and coarser in texture than the source material, a consequence of being transported about 275 meters in the dam-break flow.

**Figure 7.** Debris-flow sediments deposited on the right side of the floodplain near cross section 4. Note the coarse boulder lag on the surface, the matrix-supported gravels and cobbles, the occasional megaclasts, and the non-erosive deposition on floodplain grasses. Shovel for scale.

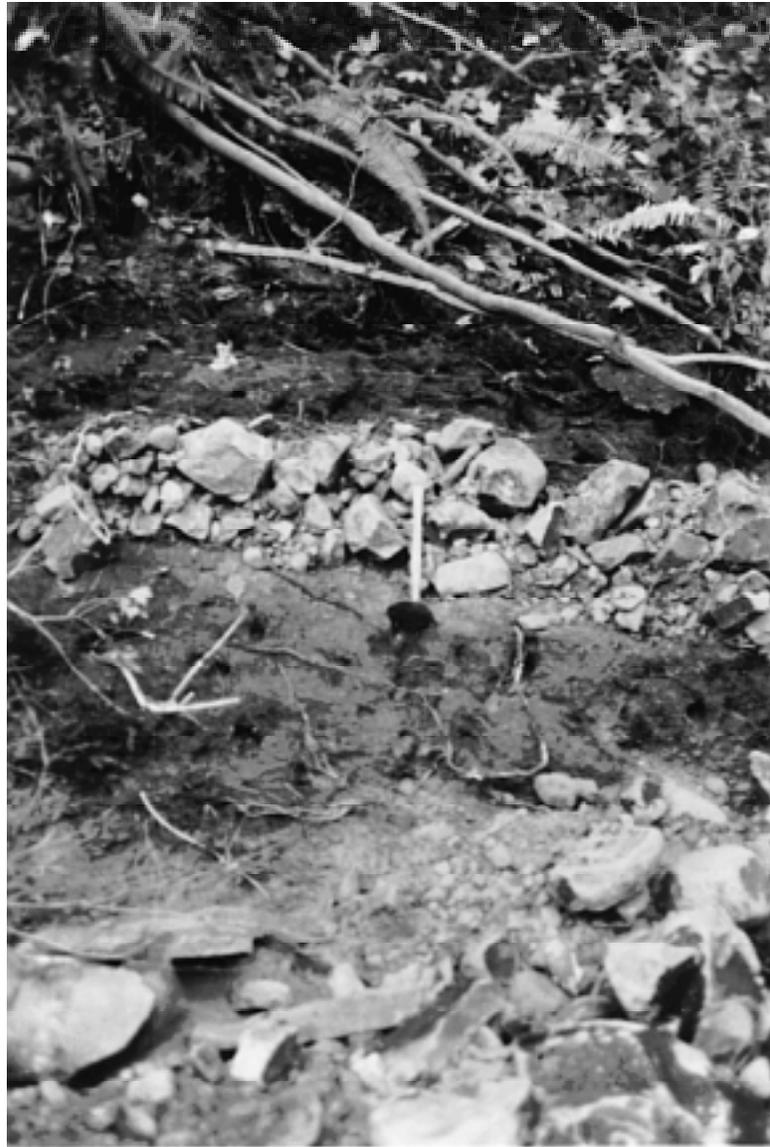
**Figure 9.** Boulder levee washed of fines along the left valley wall between cross sections 2 and 3. High water mark is about one meter above the levee, hand shovel for scale.

In several locations through the slope-area reach, paired linear ridges of clean gravel and boulders on the surface with matrix-supported gravel in the subsurface are found along both sides of the thalweg of the channel. The location, morphology, texture, and sedimentology of these boulder ridges lead to the interpretation that they are washed debris-flow levees that were deposited in the early part of the dam-break flow, then washed by a water flood a short time after emplacement (fig. 9).

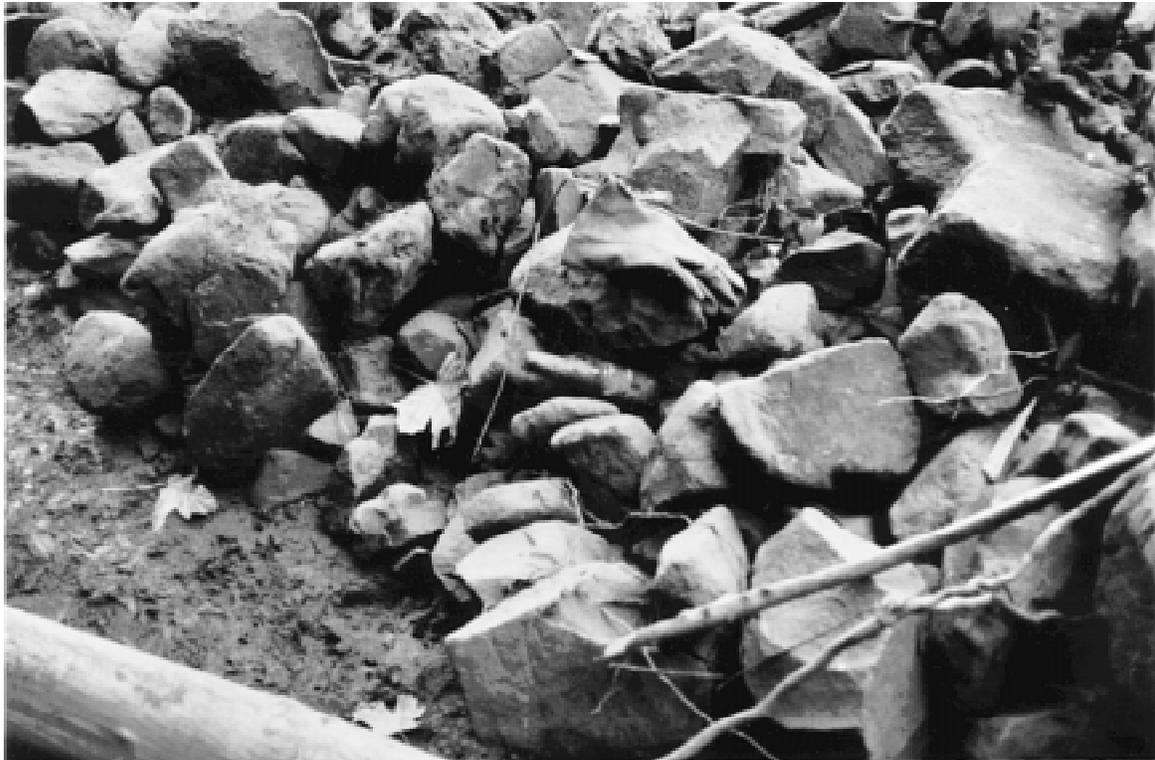
In two locations in the slope-area reach, unbroken glass beer bottles were found in a washed gravel deposit with imbricate structure (fig. 10). The bottles

had obviously been transported in a flow that was moving coarse boulders and gravel, and it is unlikely a glass bottle could survive such transport unless the flow was a near-laminar rigid visco-plastic fluid with finite shear strength, as in some debris flows. Preservation of fragile clasts and objects such as brittle shale fragments, blocks of unconsolidated colluvium, and chunks of soil source materials is characteristic of some laminar, non-deforming debris flows (Johnson, 1970; Enos, 1977).

**Figure 10.** Unbroken glass beer bottle deposited with debris-flow sediments. Location plotted on fig. 5. Glove on rock above bottle in center of photo for scale.

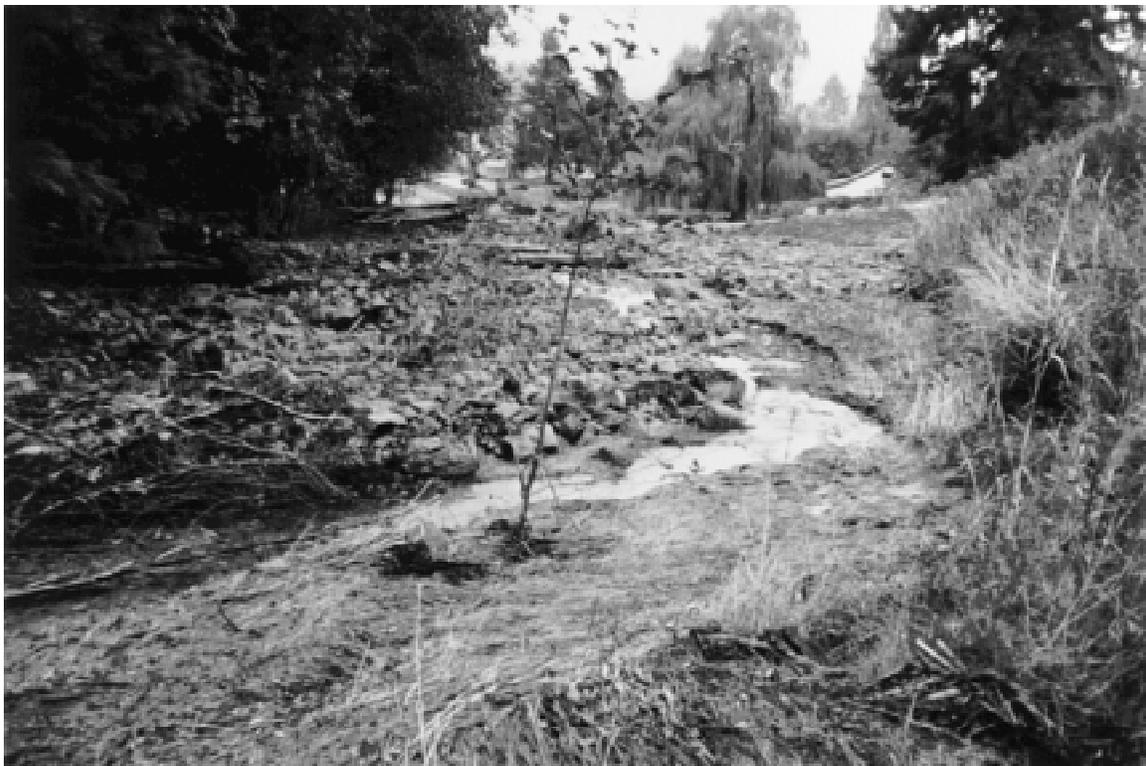
nearest the valley side had tall grasses bent in the flow direction, and little or no sediment deposited on the surface. Except for scattered gravel clasts and pieces of woody debris, the bent grass was the only indication of the flood. A 5-cm diameter alder sapling was scarred, but not bent or stripped of bark or leaves (fig. 11). This area had been swept by a short-duration water flood. Closer to the channel, gravel bars and deposits up to 0.5 meter thick appear. Trees are battered and scarred, and the original overbank surface is greatly modified by sediment deposition and some minor scour. Along the left valley wall, leaves above the high-water marks were splattered with mud. This part of the valley floor had been swept by a sediment-rich flow (fig. 11).

**Figure 11.** Flood plain in the slope-area reach. View is downstream. Debris flow inundated the floodplain on the left side of the channel. Willow in the center of photo was scarred by the water flood, but not bent or stripped of bark or leaves.

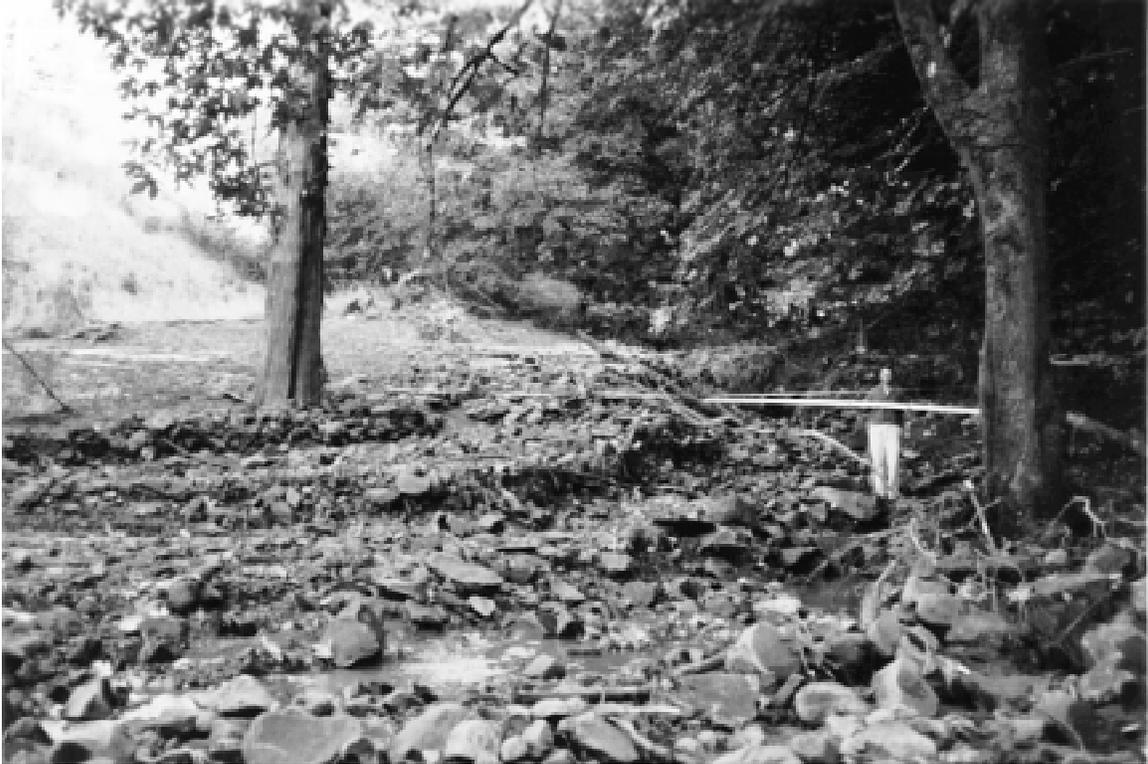
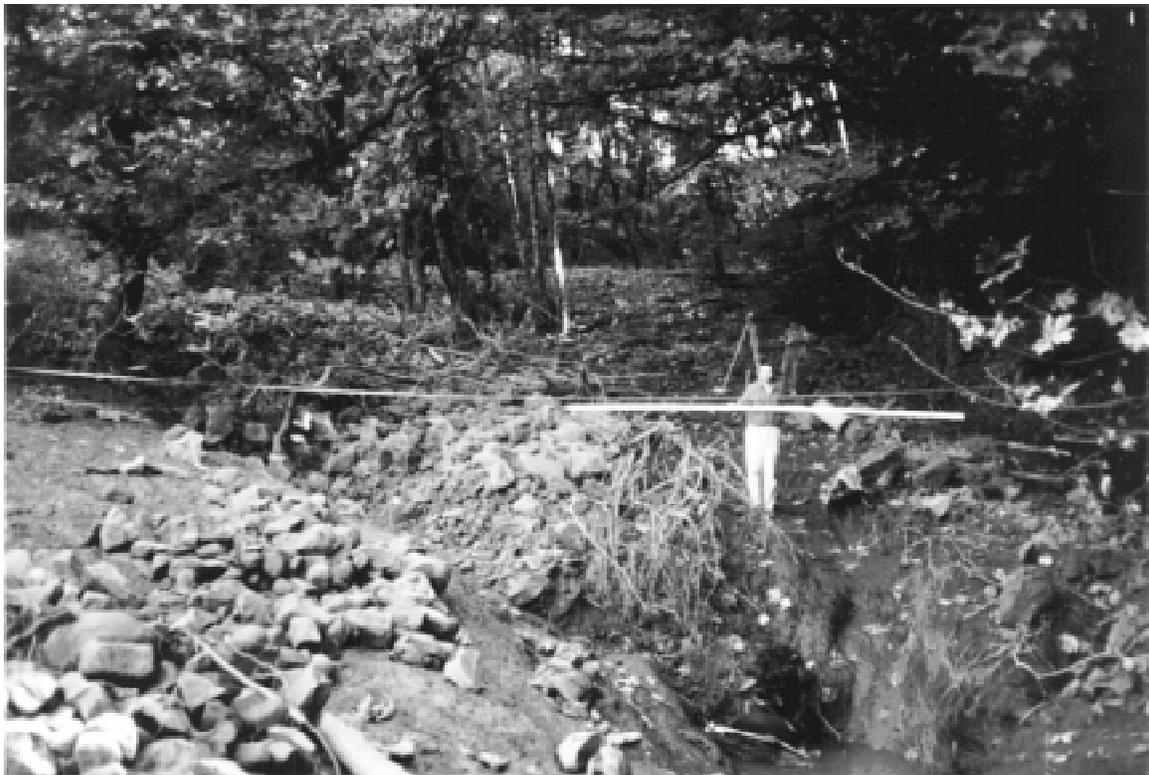
The debris flow was followed by a water flood that set high-water marks about one-half meter above the maximum stage of the debris flow. The slope-area reach is in a location where valley slope is decreasing. The initial debris flow deposited part of its volume in this reach, but this material was partially eroded by the water-flood that followed. These debris-flow deposits helped to protect the valley floor from the high velocity, shear stress, and stream power of the subsequent water-flood. There is little field evidence for erosion of original floodplain topography other than some local scour on the floodplain surface, and a 2-m deep headcut in the channel between cross section 2 and 3 (fig. 13).

**Figure 13a-b.** Cross sections 2 and 4 used in the slope-area analysis. Both views are upstream.
