# Multiple Flow Processes Accompanying a Dam-break Flood in a Small Upland Watershed, Centralia, Washington

U.S. GEOLOGICAL SURVEY

Water-Resources Investigations Report 94-4026

By John E. Costa

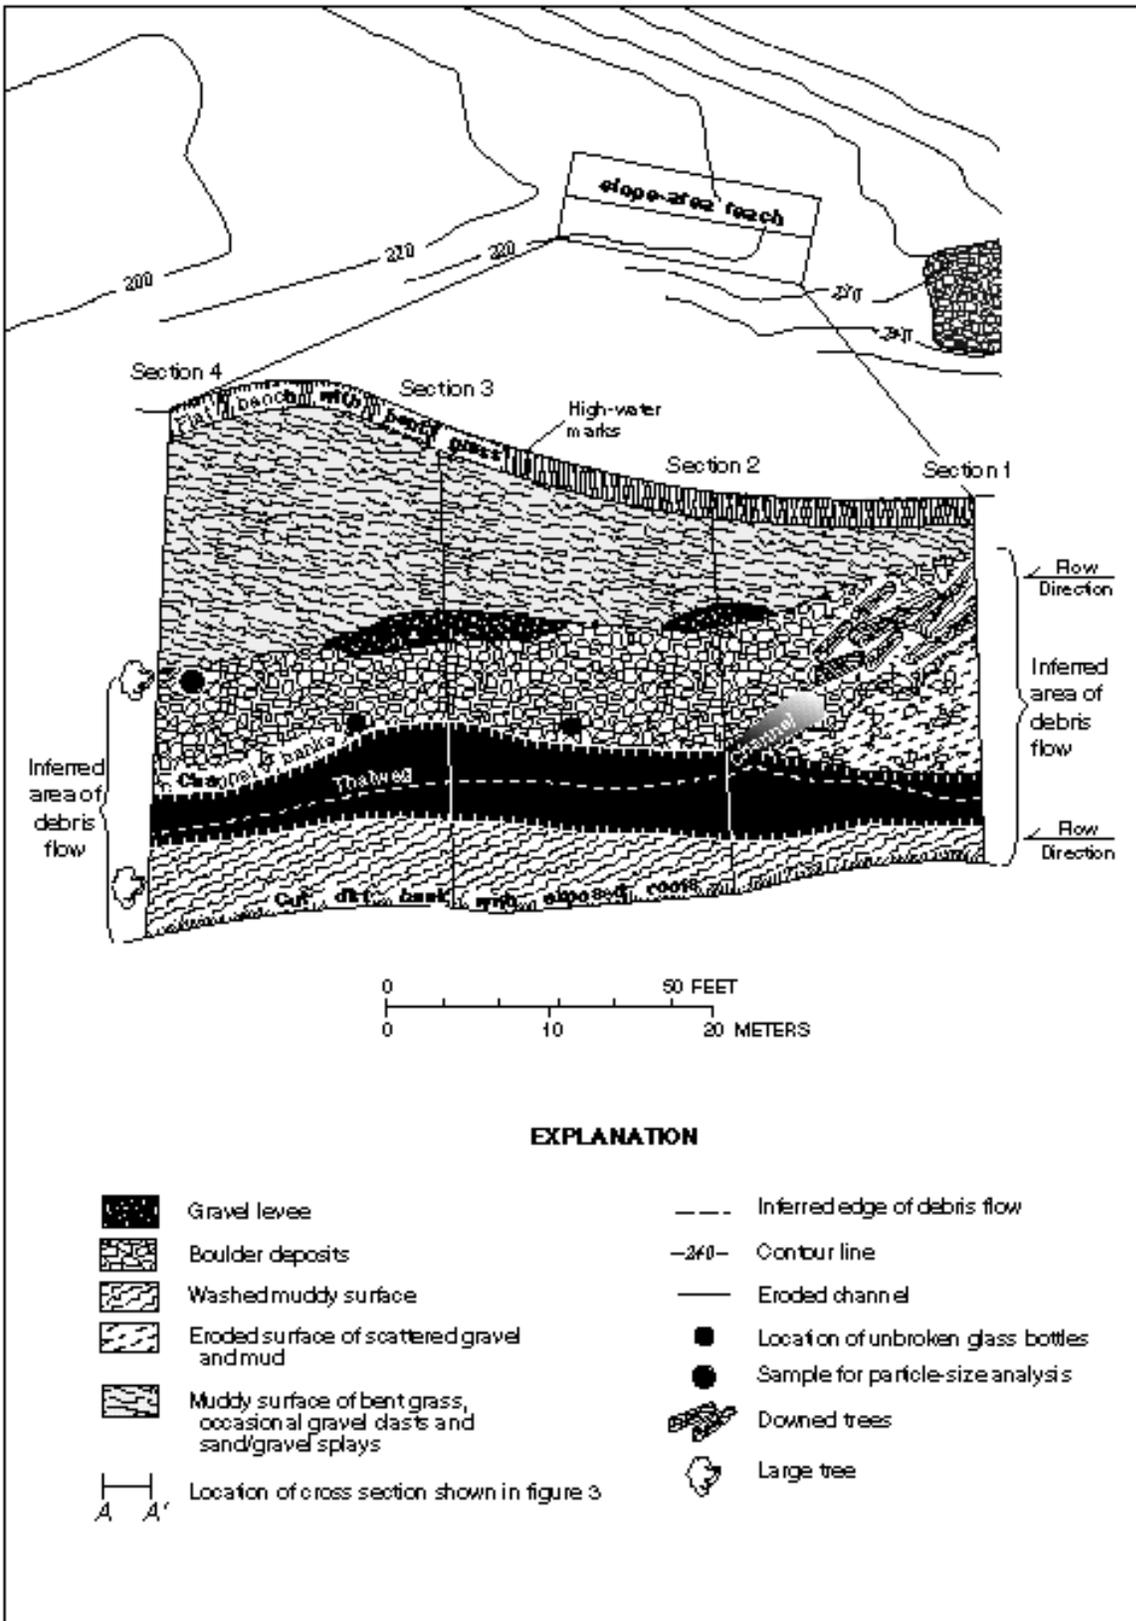
Three distinct channels were eroded into the steep hillslope below Reservoir Number 3. The channel on the north edge of the slide block is the deepest (3 - 4.5 m). The second channel (1.5 - 3 m deep) lies about 15 m south of the first channel, and the third channel (about 1 - 1.5 m deep) is about 40 m south of the first channel, near the middle of the slide block (fig. 5).

**Figure 5.** Topographic map of the slide block and slope-area reach below Reservoir Number 3. Topographic survey done in English units (feet).

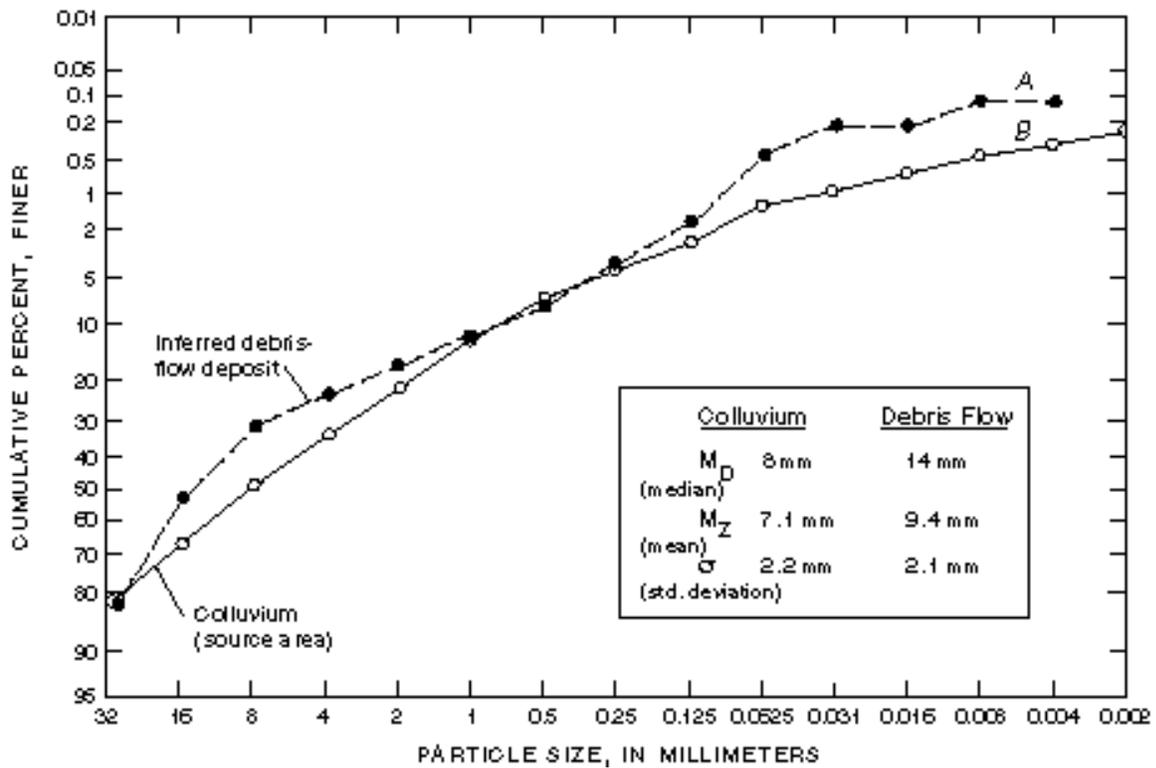
In cut banks of newly-deposited gravel in the slope-area reach, the washed surface of clean gravels and boulders was immediately underlain by a sandy gravel deposit in which many clasts were separated from others by a matrix of sand and silt (fig. 7). A mechanical analysis of one gravel sample is shown in figure 8. The median particle size is about 14 mm, and the shape of the frequency curve and sorting ( $\sigma = 2.1$ ) is characteristic of debris flow deposits (Scott, 1988). A mechanical analysis of coarse, gravel fill collected from the hillslope just below a breach in the down-dropped section of bedrock under the reservoir is also plotted in figure 8. This coarse fill is presumably the source material for most of the downstream gravel deposits. Median particle size is about 8 mm, and curve shape and sorting ( $\sigma = 2.2$ ) is very similar to the down-valley inferred debris-flow material. The derivative down-valley deposit is depleted in fines and coarser in texture than the source material, a consequence of being transported about 275 meters in the dam-break flow.

**Figure 8.** Mechanical analysis of debris-flow deposits shown in figure 7(A), and source-area gravel fill (B).

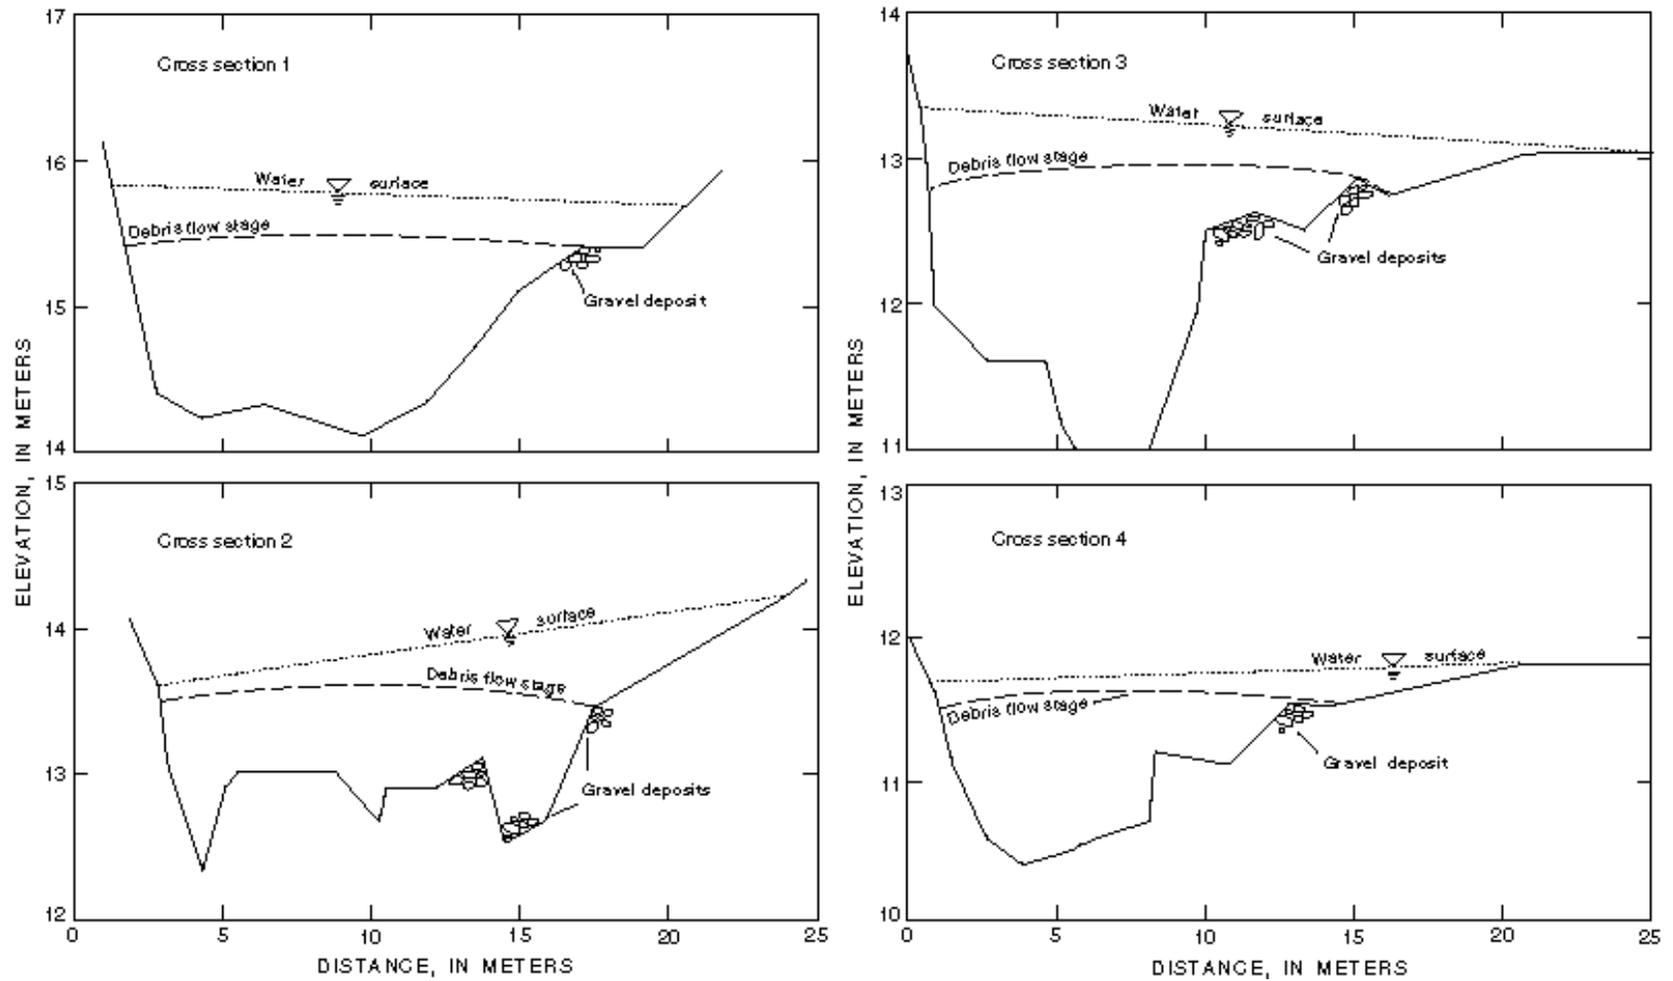
The elevation of preserved levee deposits, and the edges of gravel deposits were used to reconstruct the approximate stage of the debris flow at each of four cross sections. These stages are plotted on the cross-sections (fig. 12). No estimate of debris-flow velocity could be made from any remaining evidence such as super-elevation marks (Costa, 1984). The cross-sectional area of the debris flow decreases in the downstream direction from 13.7 m<sup>2</sup> at section no. 1, to 8.1 m<sup>2</sup> at section no. 4, 180 m downstream. Post-debris flow scour by floodwater at cross-section 3 probably accounts for the local increase in measured debris-flow area. In addition to changes in velocity, the decline in debris-flow cross-sectional area is at least partly explained by the fact that the debris flow was depositing sediment along the floodplain in the reach of the slope-area discharge measurement (table 1).

Figure 12a-d. Cross sections used in determination of peak discharge. Cross section 1 is upstream-most cross section.

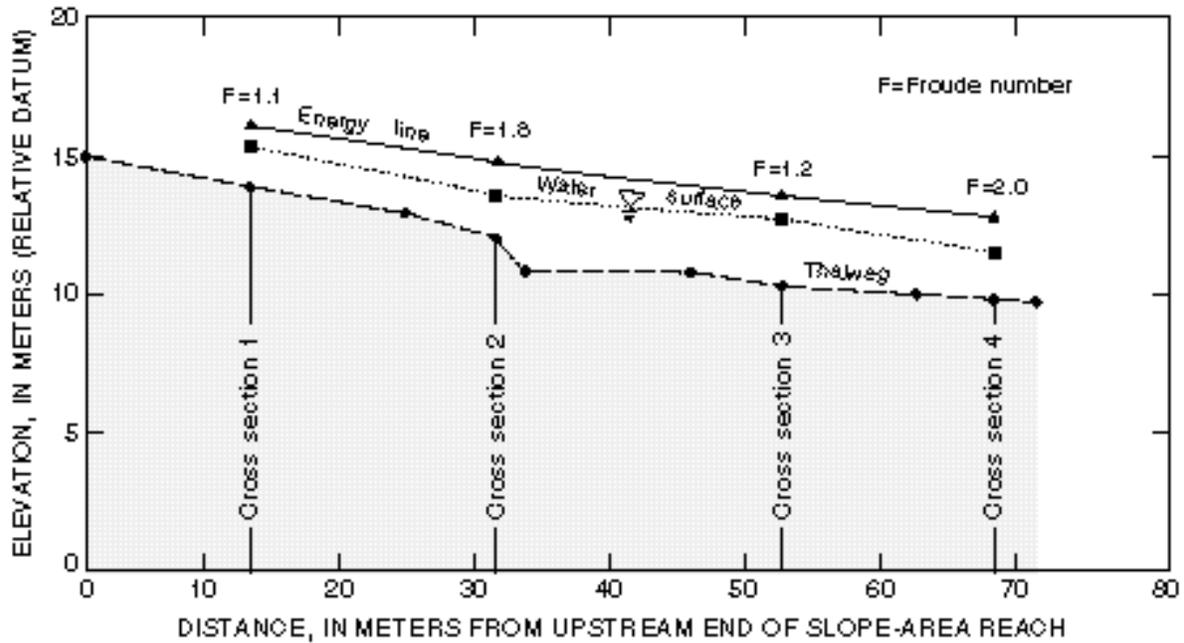
Figure 14. Total-energy diagram for the peak water-flood at Centralia, Wash.

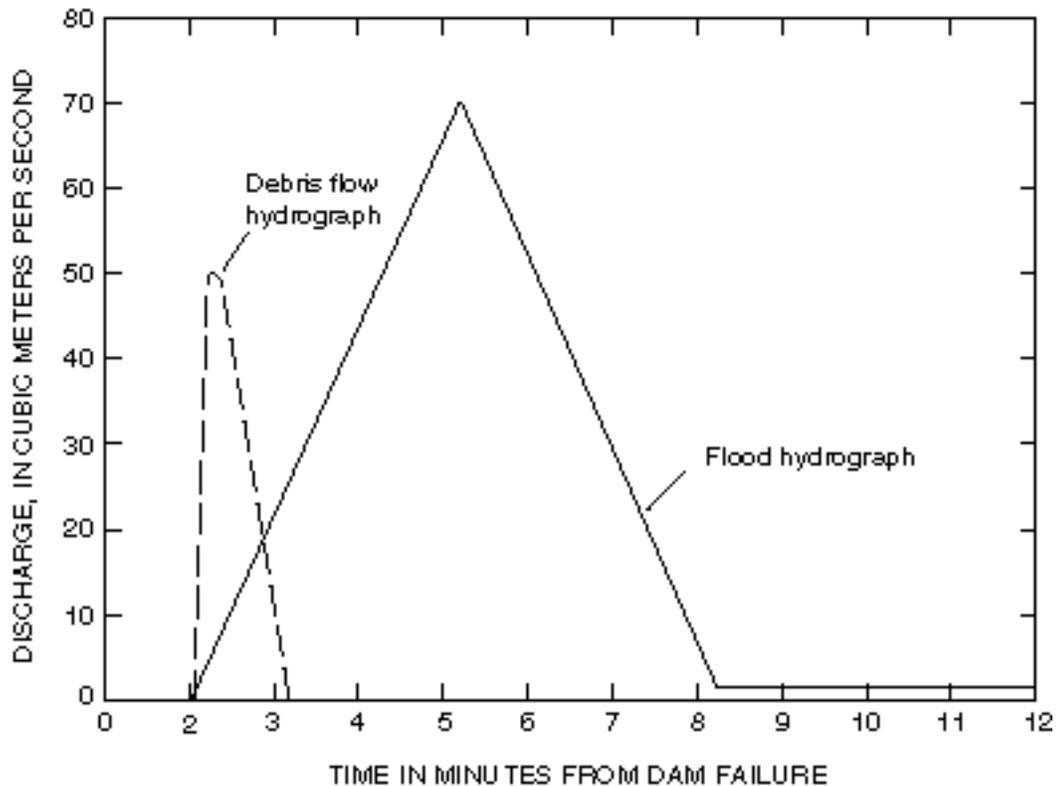
**Figure 15.** Reconstructed hydrographs of the Centralia debris flow and water-flood.

Several pieces of data about the dam-failure and resulting flood, such as reservoir volume, reports of drainage time, peak discharge calculations, and average velocity of the flood, allow construction of a flood hydrograph, and a speculative reconstructed hydrograph of the debris flow (fig. 15). The peak discharge of the water flow was 71 m<sup>3</sup>/s, and the volume of water in the reservoir was 13,250 m<sup>3</sup>. Using the average velocity of the flood through the slope area reach (4.2 m/s), it would take 1.1 minutes for the flood to travel 275 meters from the reservoir to the measurement site. If a triangular-shaped hydrograph is assumed, the area under the curve is the reservoir volume, and the base of the hydrograph, or duration of the flood past the slope-area site, would be 6.22 minutes. After 7.3 minutes from the time of the reser-

I assume that the debris flow peak discharge was  $50 \text{ m}^3/\text{s}$ , or about 70 percent of the water-flood peak discharge. Debris-flow deposits reached about 80 percent of the height of the water-flood high-water marks, and inundated about 2/3 of the area swept by the water flood. Flow velocities are assumed to have been similar. Using the above information, a tentative debris-flow hydrograph is plotted as the dashed line in figure 15. About 1/3 of the area under the debris-flow hydrograph overlaps the water-flood hydrograph, and the remaining 2/3 of the debris-flow hydrograph, not included in the water-flood hydrograph, is sediment. This suggests the volume of the debris flow was about  $1,800 \text{ m}^3$ .

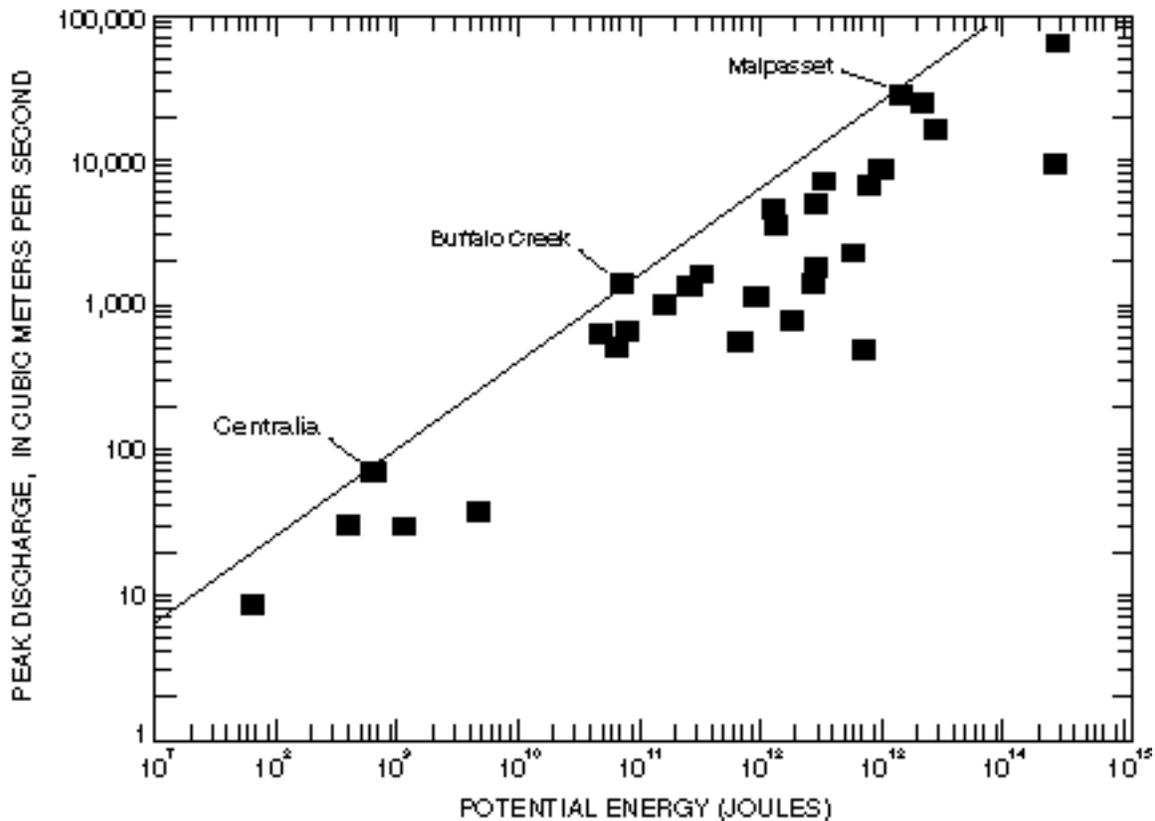
The collapse of the southwestern side of Reservoir Number 3 opened a large breach in the side of the reservoir and allowed  $13,250 \text{ m}^3$  of water to escape rapidly. The resulting flood peak-discharge a short distance downvalley ranks as one of the largest floods documented from the failure of a constructed dam for the available potential energy of water in the dam prior to failure (fig. 16). The data in figure 16 include earthen and rigid concrete dams that have failed by a variety of processes, and for which reasonable estimates of peak flood discharge exist (Costa, 1988). Three dam failures define the limiting line for data of potential energy as a function of peak flood discharge: Buffalo Creek, W.Va.; Malpasset Dam, France, and Reservoir Number 3, Centralia, Wash.

Failure mechanisms for many of the other dams plotted in figure 16, primarily overtopping, did not lead to an instantaneous release of water. Breaches that formed during overtopping grew gradually, and other kinds of foundation failures were not so catastrophic as the rapid mass movements that caused the dam failures that determine the location of the envelope curve. The Centralia, Wash. reservoir failure defines the location of the envelope curve at the low end of the available data, and thus represents an important hydrologic event for identifying the limit of the size of floods from dams that differ in size and in failure mechanism.

**Figure 16 .** Potential energy versus peak discharge for constructed dams. Envelope curve is defined by the French Malpasset Dam failure (Jansen, 1980), the Buffalo Creek, W. Va. coal-spoil dam failure (Davies and others, 1972), and the Centralia, Wash. reservoir failure. Data from Costa (1988).
